FHWA/CA/ESC-98/02

Vehicular Crash Tests of a Slip-formed, Single Slope, Concrete Median Barrier

December 1997

Material Engineering and Testing Services
California Department of Transportation
5900 Folsom Blvd., PO Box 19128
Sacramento, Ca. 95819

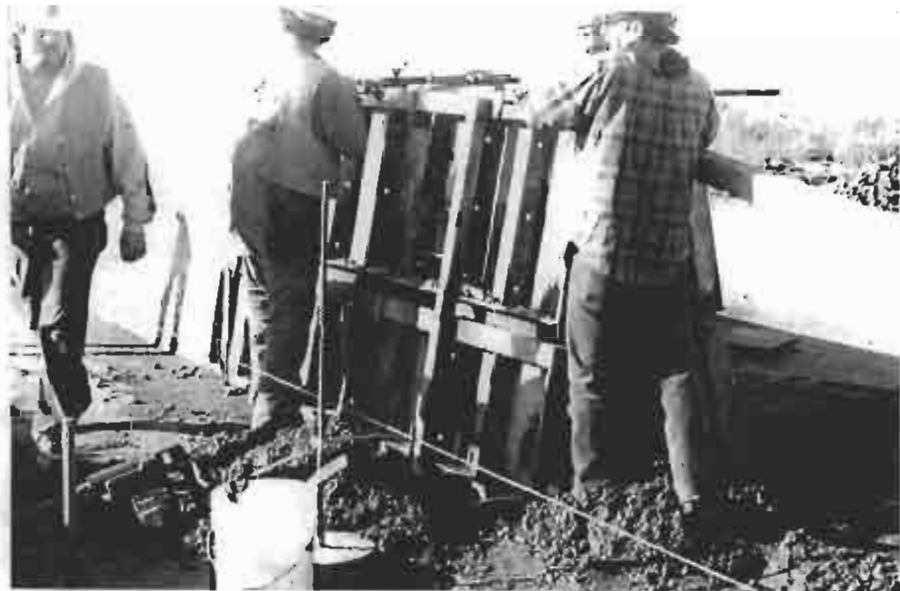
Even though the contractor eventually mastered the nuances of the slip-forming operation, considerable patch work was required in order to get the barriers to conform to the required profiles. Most of the patching had to be done at the ends of the barriers where the mule had to be put on or taken off the barriers. Plywood forms had to be used at the beginning of each slip-forming operation due to a lack of proper consolidation of the concrete before the mules were first moved. Forms also had to be used at the end of each operation due to the need for vertical steel reinforcement. The mules had to be lifted vertically off the barriers, then barrier end forms set in place before the anchors were cast.

Figure 2.9 - The Ends Could Not Be Slipformed Because Of The Vertical Rebar.

Figure 2.10 - The End Forms Were Held In Place With Bar Clamps.

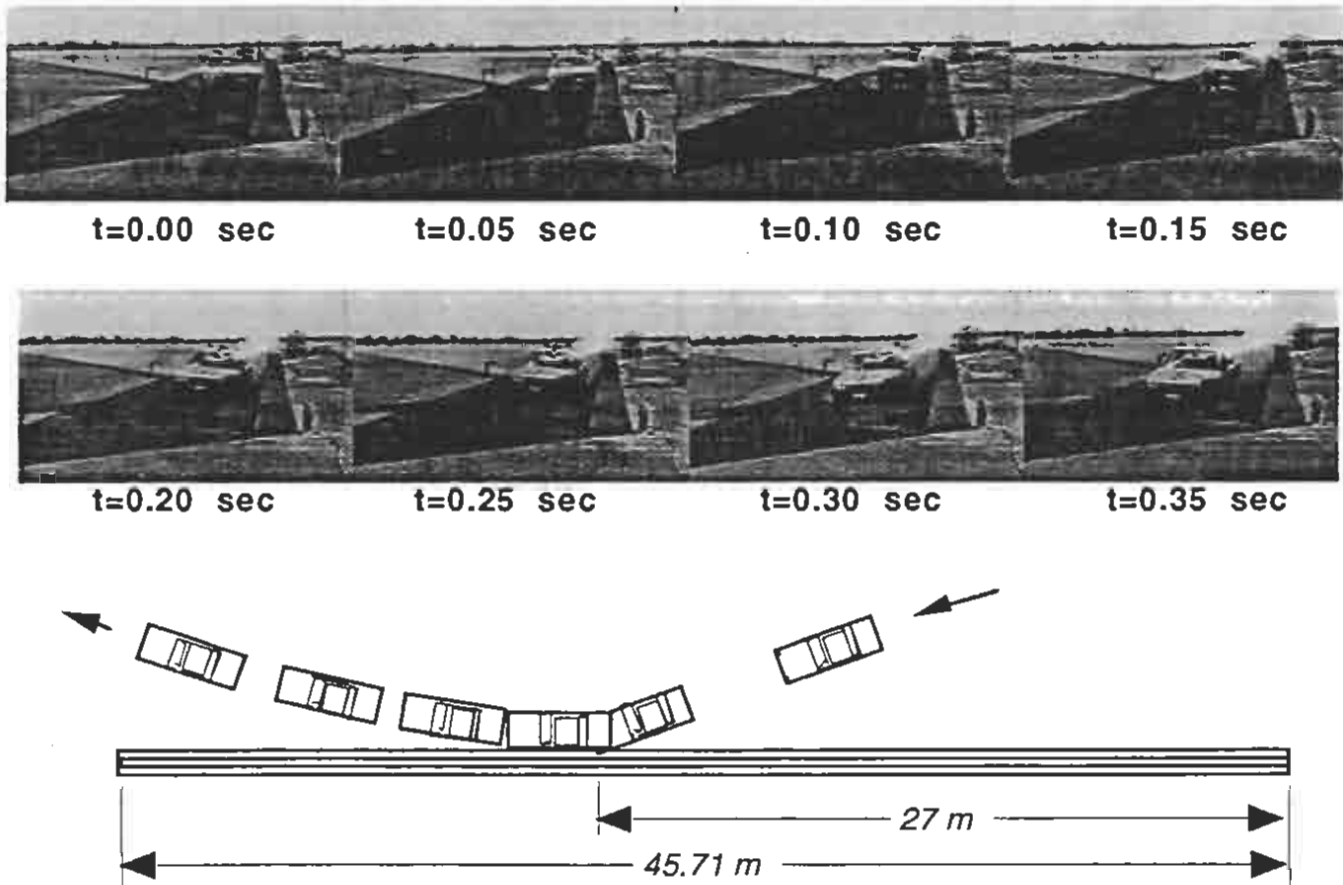
Figure 2.16 - Test 531 Data Summary Sheet

Test Barrier	
Type:	Texas Barrier w/glare screen
Length:	50 meters
Test Date:	February 9, 1995
Test Vehicle:	
Model:	1990 Toyota Tercel
Inertial Mass:	865 kg
Impact / Exit Velocity:	91.8 km/h / 83 km/h
Impact / Exit Angle:	19.8° / 6.6°
Test Dummy	
Type:	Part 572 50th percentile male
Weight / Restraint:	165 lbs / lap and shoulder
Position:	Driver's Seat
Test Data:	
Occ. Impact Velocity (Long / Lat):	4.60 m/s / -6.83 m/s
Ridedown Acceleration (Long / Lat):	-2.6g / 11.3g
Max. 50 ms Avg. Accel (Long / Lat):	-7.2g / 12.8g
Exterior: VDS/CDC ²	FL-3, LD-5 / 12LFEK2
Interior: OCDI ¹⁰	LF0000000
Barrier Damage:	Only superficial scuffing

Damage to the vehicle was moderate. The front left corner of the vehicle sustained the most damage, but additional sheet metal crushing and scraping occurred along the entire left side of the vehicle.

The initial impact caused the bumper to turn inward toward the tire. The front left tire impacted the barrier with enough force to tear it from the suspension, leaving only the strut to hold the wheel assembly onto the frame. Near the point of impact the hood was slightly crumpled.

Barrier damage was cosmetic only, consisting of scrapes and tire marks. Both left tires left marks along the face of the barrier for the three to four meters of contact. Small amounts of concrete spalled from the face of the barrier where the vehicle's sheet metal made contact.

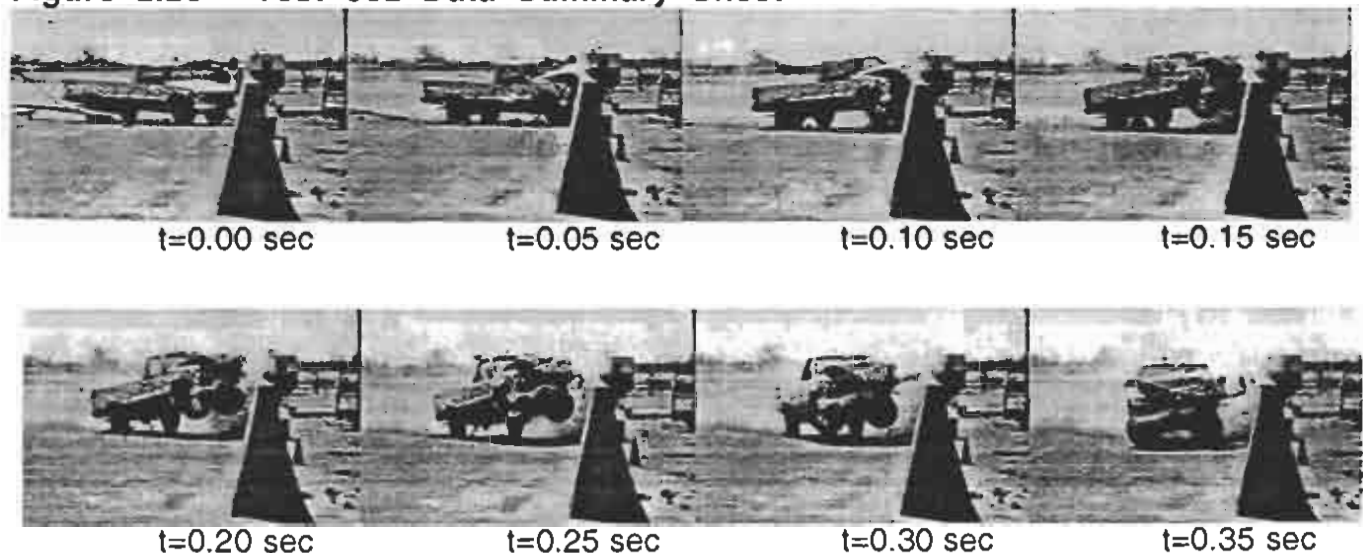
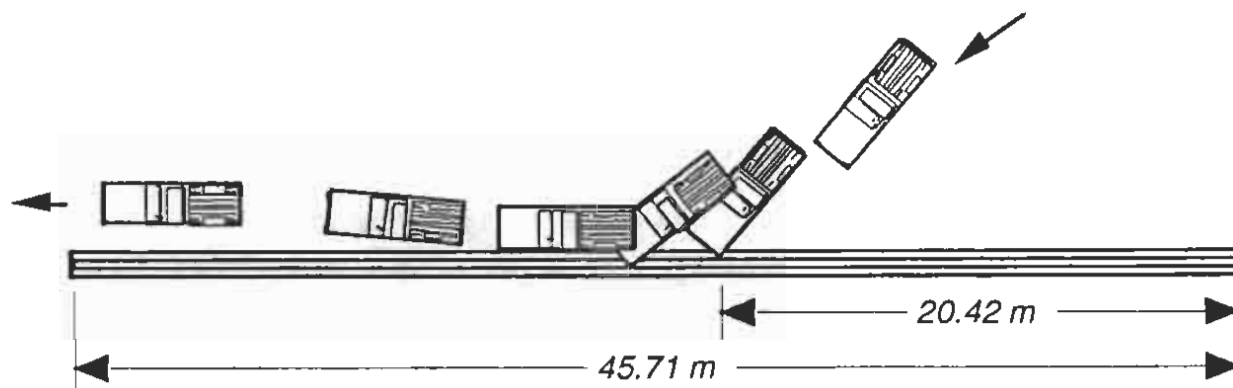
Figure 2.23 - Test 532 Data Summary Sheet

Test Barrier		
Type:	Texas Barrier w/glare screen	
Length:	50 meters	
Test Date:	March 16, 1995	
Test Vehicle:		
Model:	1991 Chevy pickup	
Inertial Mass:	2000 kg	
Impact / Exit Velocity:	71.5 km/h / 33 km/h	
Impact / Exit Angle:	53° / 2°	
Impact Yaw angle	-19°	
Test Dummy		
Type:	none	
Weight / Restraint:	NA	
Position:	NA	
Test Data		
Occ Impact Velocity (Long / Lat):	not avail.	
Ridedown Acceleration (Long / Lat):	not avail.	
Max. 50 ms Avg. Accel (Long / Lat):	not avail.	
Exterior: VDS/CDC ²	FC-5, FL-4, LD-5 / 12LFEK4	
Interior: OCDI ¹⁰	LF1032122	
Barrier Damage:	Only superficial scuffing

Damage to the vehicle was severe. The front left corner of the vehicle sustained the most damage, but additional sheet metal crushing and scraping occurred along the entire left side of the vehicle.

The initial impact caused the bumper to tear away from the vehicle. The front left tire impacted the barrier with enough force to tear it from the suspension, leaving only the strut to hold the wheel assembly onto the frame.

Barrier damage was cosmetic only, consisting of scrapes and tire marks. Small amounts of concrete spalled from the face of the barrier where the vehicle's sheet metal made contact.

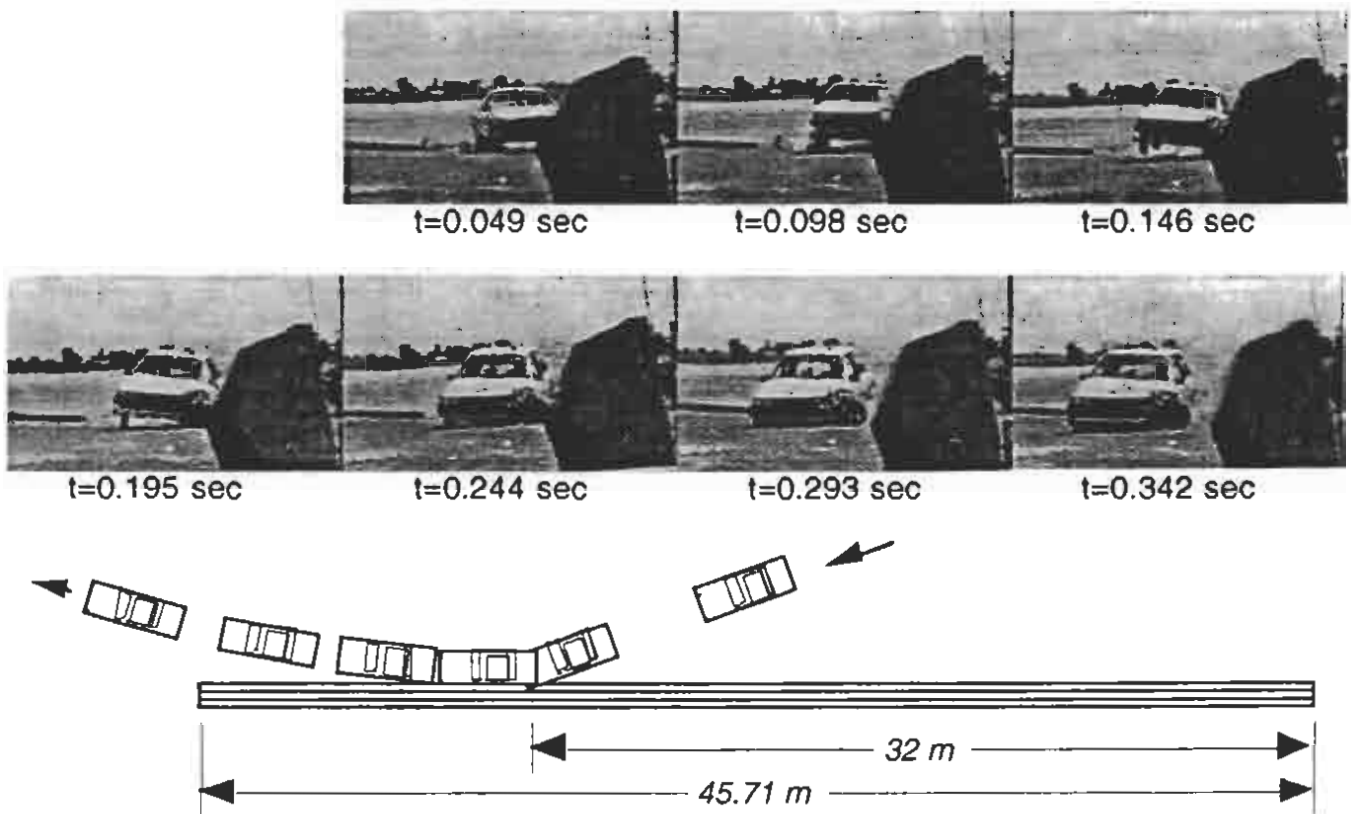
Figure 2.30 - Test 533 Data Summary Sheet

Test Barrier	
Type::	Type 60G
Length:	50 meters
Test Date:	June 7, 1995
Test Vehicle:	
Model::	1990 Toyota Tercel
Inertial Mass:	845 kg
Impact / Exit Velocity:	92.9 km/h / 79.4 km/h
Impact / Exit Angle:	19.5° / 6.5°
Test Dummy:	
Type:	Part 572 50th percentile male
Weight / Restraint:	74.8 kg / lap and shoulder
Position:	Driver's Seat
Test Data:	
Occ. Impact Velocity (Long / Lat):	4.72m/s / -7.9m/s
Ridedown Acceleration (Long / Lat):	-2.1g / 16.7g
Max. 50 ms Avg. Accel (Long / Lat):	-7.2g / 14.2g
Exterior: VDS/CDC ⁹	FL-3, LD-5 / 11LFEK2
Interior: OCDI ¹⁰	LF1011144
Barrier Damage:	Only superficial scuffing

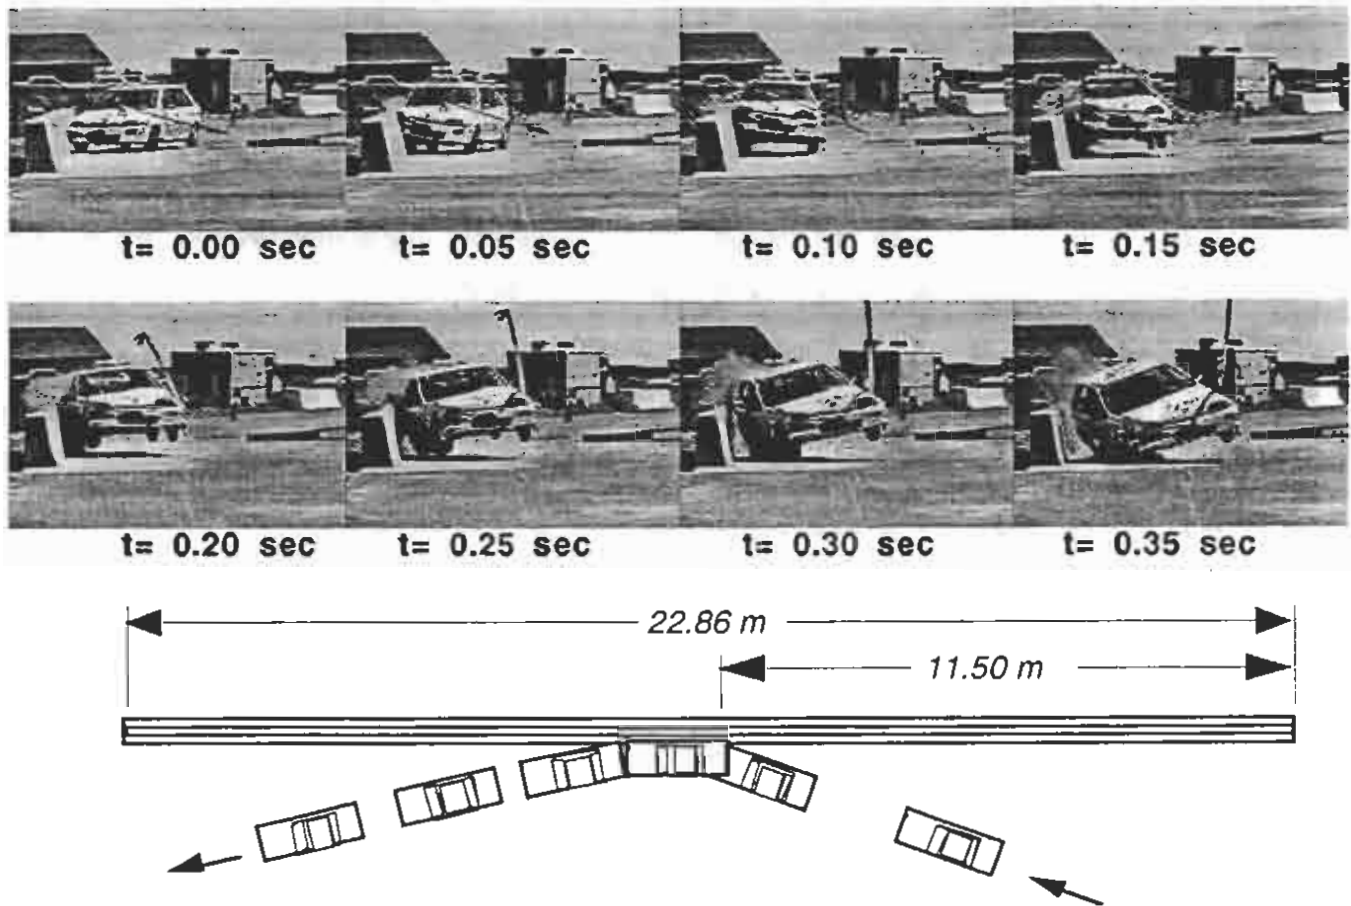
Figure 2.43 - Test 511 Data Summary Sheet

Test Barrier	
Type:	Type 70 Bridge Rail
Length:	22.86 meters
Test Date:	April 6, 1997
Test Vehicle:	
Model:	1992 Geo Metro
Inertial Mass:	843 kg
Impact / Exit Velocity:	104.1 km/h / 92 km/h
Impact / Exit Angle:	20.0 / 12.1°
Test Dummy:	
Type:	Hybrid III
Weight / Restraint:	74.8 kg / lap and shoulder
Position:	Front Right
Test Data:	
Occ. Impact Velocity (Long / Lat):	4.51 m/s / 7.22 m/s
Ridedown Acceleration (Long / Lat):	-2.9g / -16.0g
Max. 50 ms Avg. Accel (Long / Lat):	-7.0g / -13.4g
Exterior: VDS/CDC [®]	FR-5, RD-4 / 12RFEW3
Interior: OCDI [®]	RF0000110
Barrier Damage:	Only superficial scuffing
